AFATL-TR-67-55

Three Full-Scale Dynamic Crash Tests of a CNU-103/E Shipping Container

Technical Report AFATL-TR-67-55

MAY 1967

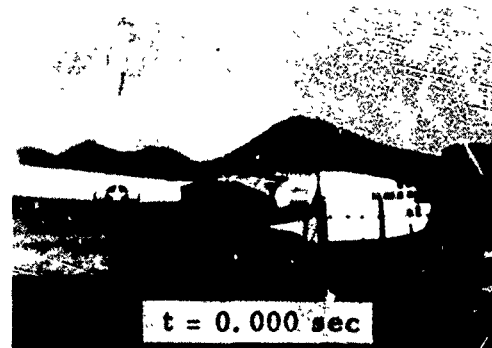
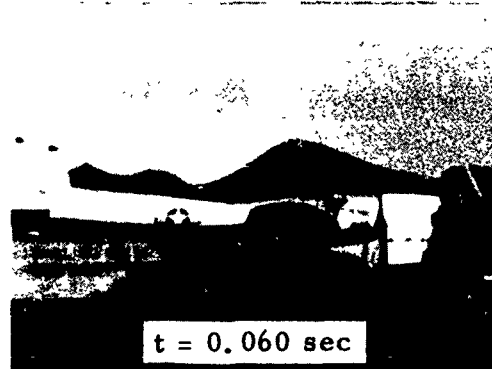
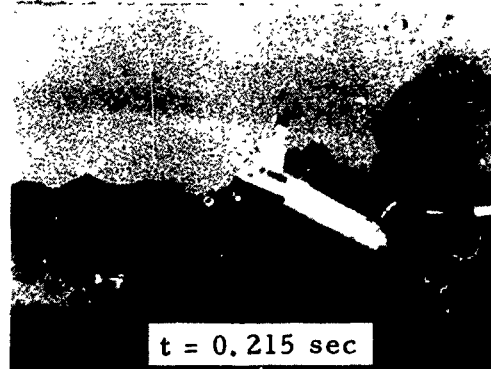
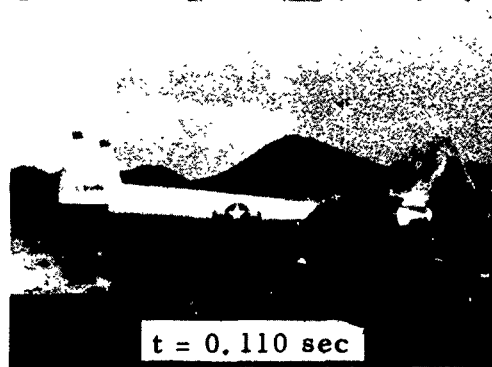
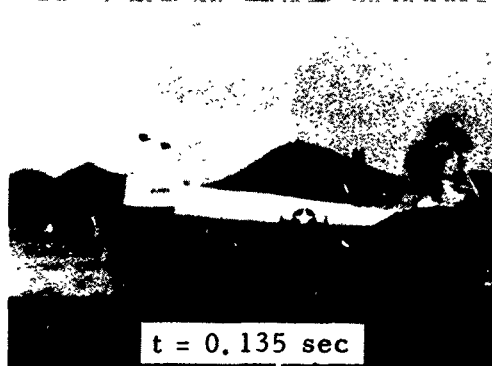
Figure 13. Crash Sequence - Test 1.

The impact sequence for the CNU-103/E Shipping Container as reconstructed from high-speed photography indicates that the container remained attached to the pallet and fuselage floor during the crushing of the forward aircraft fuselage. At contact of the propellers and engine nacelle with the concrete wall, sufficient longitudinal deceleration was generated to release the container from the pallet. However, at this point there could have been only 17 inches between the forward edge of the Shipping Container and the wall. This 17 inches was filled with the crushed portion of the forward fuselage so there was little, if any, forward motion of the container, relative to the pallet, at any time during the impact. Therefore, the longitudinal velocity of the Shipping Container at point of contact with the wall was the same as the aircraft fuselage. Analysis of the high-speed film and integration of the fuselage acceleration-time history has determined this velocity to be 190 feet per second.

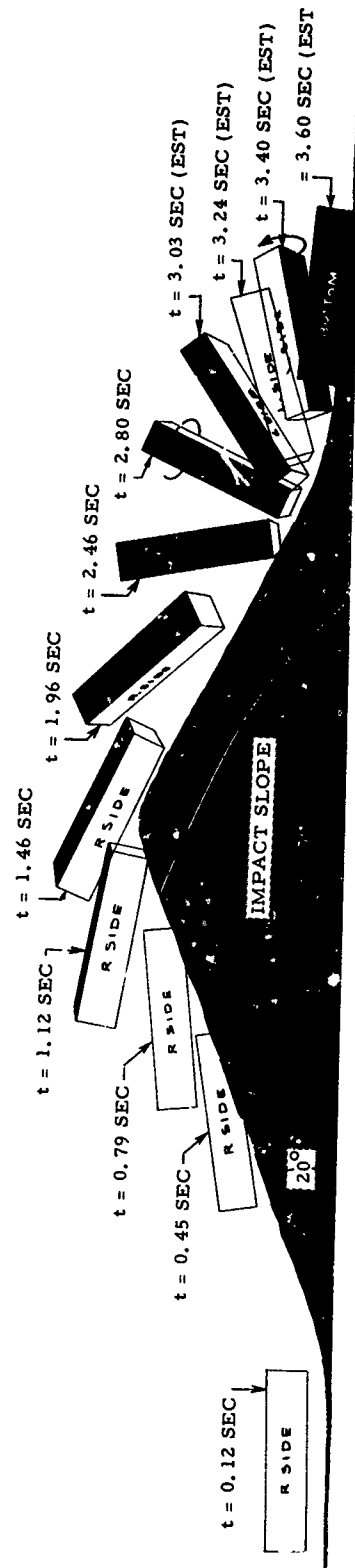
Figure 23. Shipping Container Crash Kinematics - Test 3.

A graphic display of container crash kinematics as determined from the high-speed film analysis is presented in Figure 23.

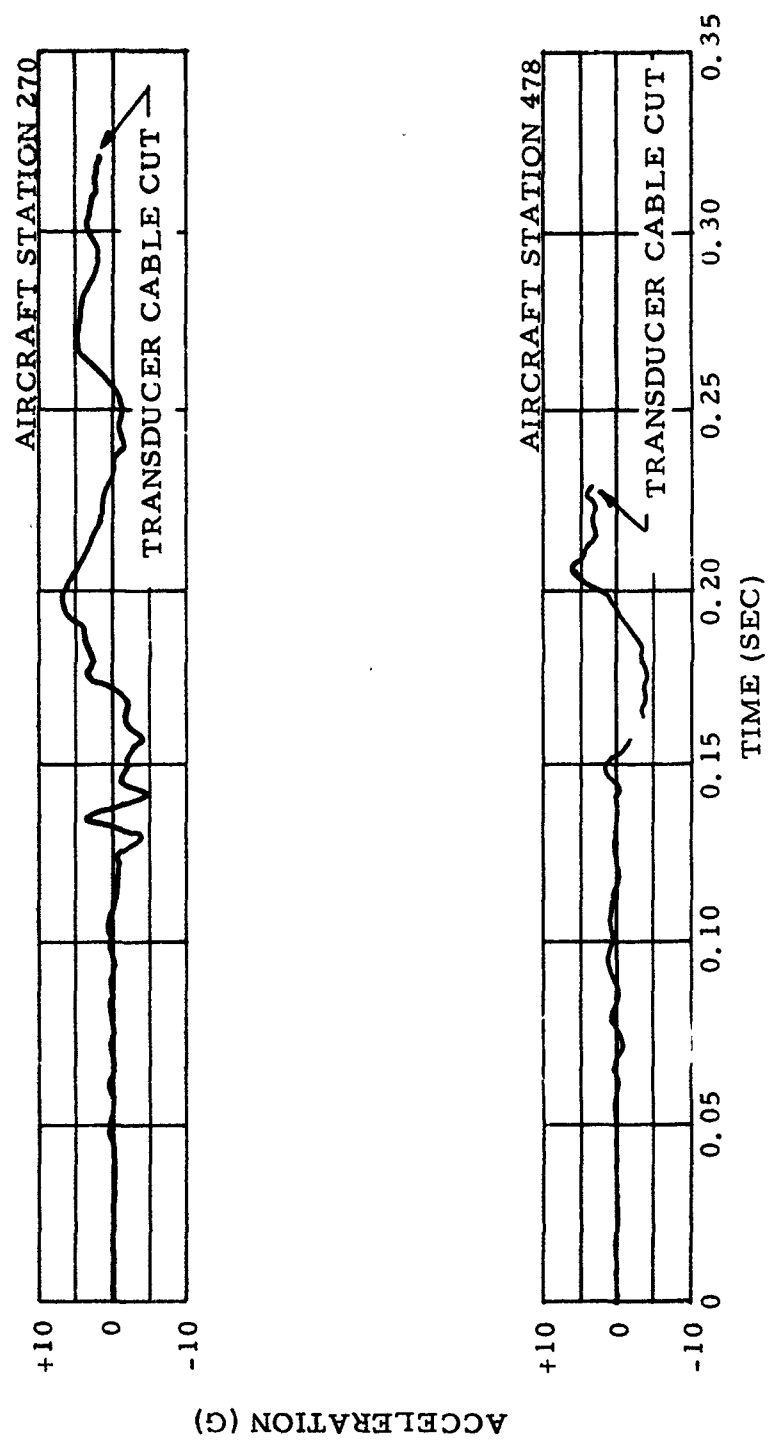
Figure I-8. Aircraft Fuselage Lateral Acceleration - Test 3.

DATA FROM THE LOCATION WAS NOT RECORDED
DUE TO FAILURE OF TRANSDUCER PRIOR TO TEST
